# linea 9001

## TEXTURE, TYPE & COLOUR

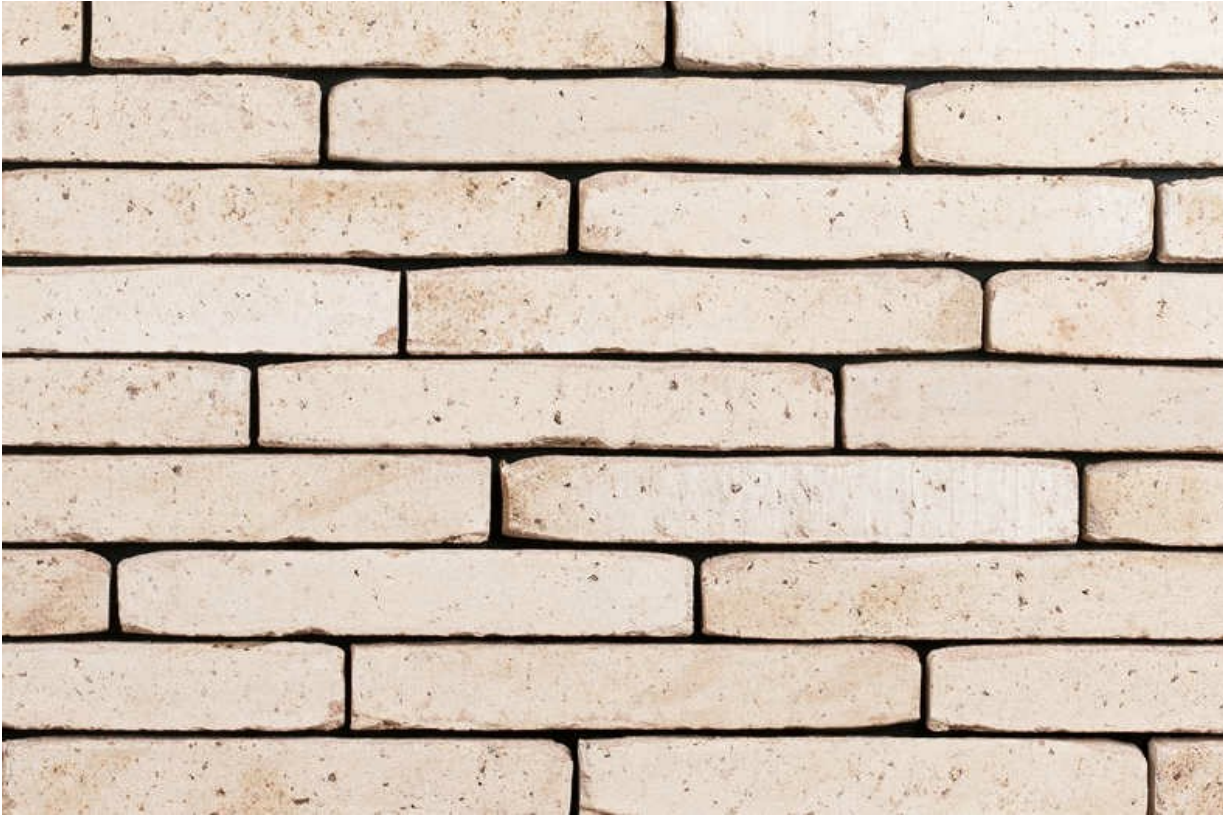
## Productshot

The decorative brickwork (inside and/or outside face) is made with a solid unsanded moulded brick without grain with a very uneven structure. Due to the natural reduction with coal the bricks have a strong fired rough field fire aspect. Some visible sides of the brick also contain traces of coal and of the manual production method. The colour is ecru to cream-white with nuances through and through.
