Veldbrand Red

VANDE MOORTELE
CLAY PAVERS • FACING BRICKS • SLIP!

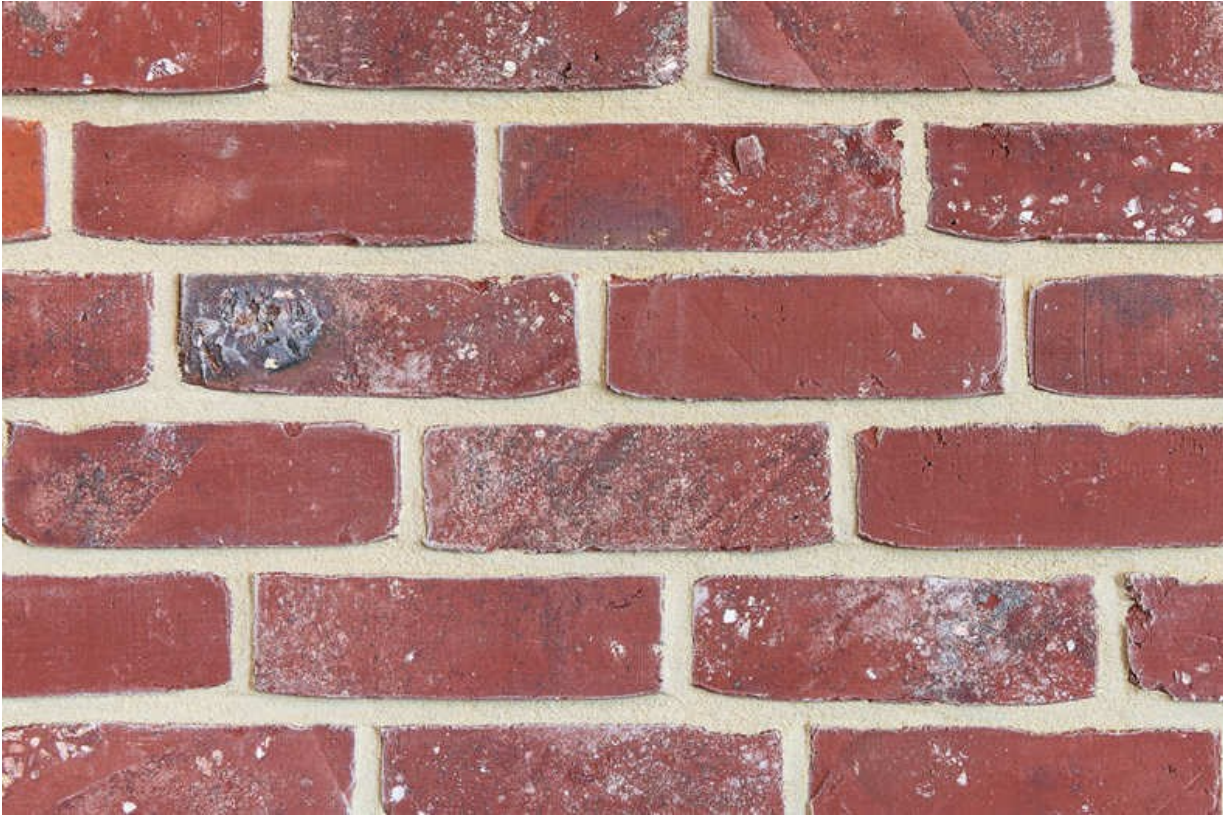
Productshot

The decorative brickwork (inside and/or outside face) is made with a solid unsanded moulded brick without grain with a very uneven structure. Due to the natural reduction with coal the bricks have a strong fired rough field fire aspect. Some visible sides of the brick also contain traces of coal and of the manual production method. The colour is red-brown to violet-blue with nuances.
