# linea 6012

## TEXTURE, TYPE & COLOUR

## TECHNICAL CHARACTERISTICS

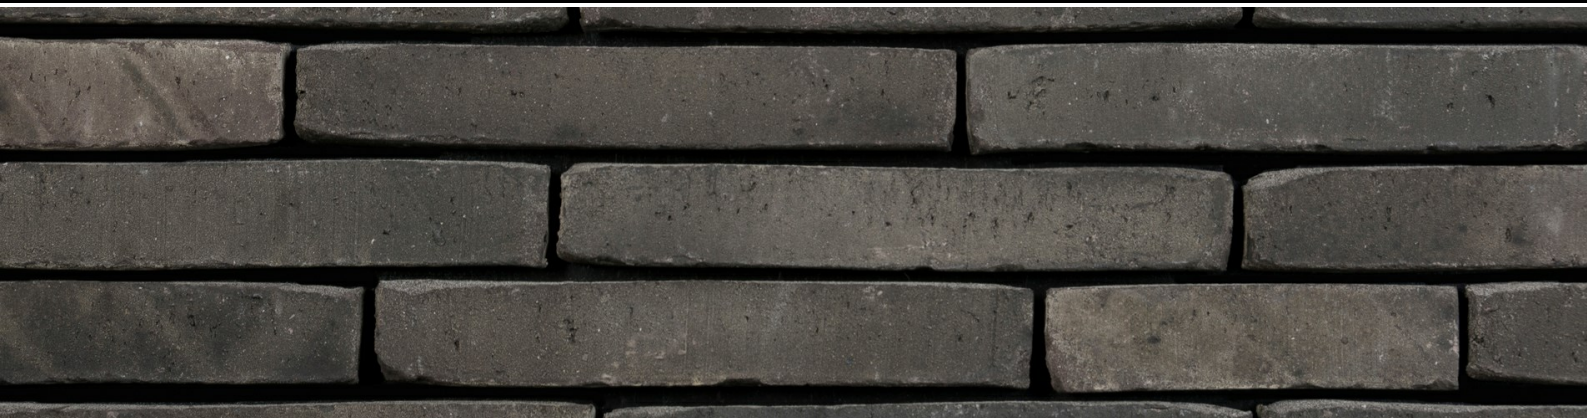
The decorative brickwork (inside and/or outside face) is made with a solid unsanded moulded brick without grain with a very uneven structure. Due to the natural reduction with coal the bricks have a strong fired rough field fire aspect. Some visible sides of the brick also contain traces of coal and of the manual production method. The colour of the body is grey-green-brown to black-green with nuances.
